Technical Bulletin No: 27-2016

Title:	HireTech HT7 Edging Sander Maintenance	
Priority	Amber – Non-Conformance Minor – Major in some instances	
Legislation:	PUWER, E@WR	
Brief Description:	During SafeHire audits a range of issues have been identified due to poor maintenance on HT7 sanders. This bulletin covers the most common issues that should be addressed.	
Equipment Affected:	HireTech HT7 Edging Sander	
1 – Castors locknut loose, poorly adjusted, castors tight in operation	2- Gearbox breather hole blocked / covered with company decal	3 – Cable worn through / arctic cable used rather than H07

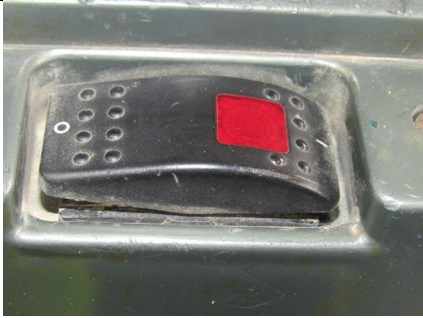
4 – Switch sticking in on position – should be momentary	5- Top cover cracked / broken - replace	6 –Incorrect wiring - trapped between frame and cover

Recommended Actions:	<ul style="list-style-type: none"> • Review above with workshop teams / audit ready for hire equipment • Use H07 or equivalent cable with minimum 1.5mm² cores • Consider installing a suitable connector to ease cable replacement when client 'sands' the cable – 10 amp for 230v as per link below. 16 amp is required for 110v. • http://uk.rs-online.com/web/p/mains-inline-connectors/0531431/ 	
Circulation:	Management / Workshop Team

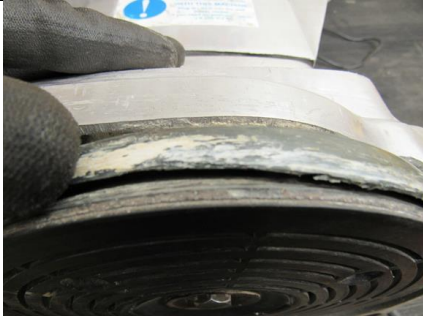
7 – Skirting protector seized, should freely rotate	8- Multiple discs fitted as height incorrectly set	9 –Poor plug wiring / fuse clip loose – see Tech Bulletin 8
