Technical Bulletin No: 3-2014

Title:		Dustcontrol Vacuum Servicing / Handover	
Priority		Red – Audit Rating: Non-Conformance - Major	
Legislation:		PUWER, HASWA S.6, CoSHH	
Brief	£	During SafeHire audits a number of issues have been found regarding the condition of	
		Dustcontrol vacuum filters and risk of contamination during servicing and use on next	
Descript	lion.	hire. Please review current Dustcontrol operator instruction leaflet.	
Kit Affec	ted:	Dustcontrol DC1800, DC2800, DC2900, DC3800 / Twin	
Images / Description

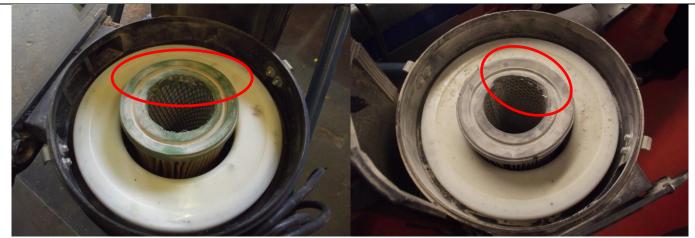
Hepa Filter (inner / secondary filter) should be fitted to motor unit / head and then installed, filter is damaged if motor unit is attached with filter in the base unit as per image below. Clean-side of machine should be exactly that, check for dust and contamination after the filter. Do not use air-lines to clean equipment, washing or use of extraction / vacuums to aid service of these machines is recommended.

100% checks of filter installation / cleanliness and ensuring reverse pulse cleaning is		
Recommended	demonstrated. In addition HAE to issue a product specific Safety Guidence leaflet.		
Actions:	Consider use of washable filters to ease dust management during service and issue		
	enough debris bags at point of hire e.g. 1 per day or more on sale or return basis.		
Notes:	Please contact: safehire@hae.org.uk if you identify any issues that may identify a		
Notes.	manufacturer / model specific issue.		
Circulation:	workshops, mobile service and management team

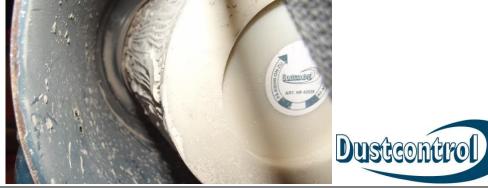
Primary / Outer filter – heavily contaminated – reverse pulse cleaning has not been completed during hire / at service. Filter life is in excess of 12 months if serviced correctly Note: Washable filters are available.
