# Technical Bulletin No: 41-2019

| <b>Title:</b> | <b>Power Cable Inspection</b> | |
| <b>Brief Description:</b> | Power cable damage and suitability is the most common issue raised on product review during SafeHire audits – this bulletin provides guidance on what is acceptable | |

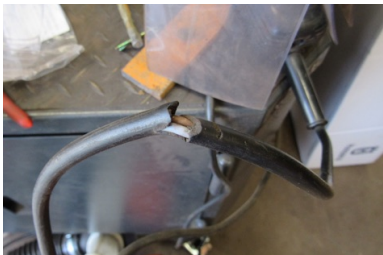
| <b>1 – Cable Damaged</b><br>Obvious damage to cable sheath | <b>2 – Cable Worn - Sanding</b><br>Insulation Thickness Affected / Poor Repair – Heat-shrink Non-Standard Cable used – should be as per new machine | <b>3 – Cable Cut – Door Trapping</b><br>Very common extension lead damage, snagged or trapped in door during use / full extension lead length should be checked |

| <b>Recommended Actions:</b> | <ul style="list-style-type: none"> <li>Review hire fleet and work equipment as per this bulletin and related HAE Technical Bulletins including Bulletin 1, 8, 19 and 30</li> <li>All cables should be fully inspected every hire for hire fleet equipment. Cables should be pre-use checked for work equipment by the end user</li> <li>Ensure power supply is isolated / plug disconnected before cables are inspected</li> </ul> | |

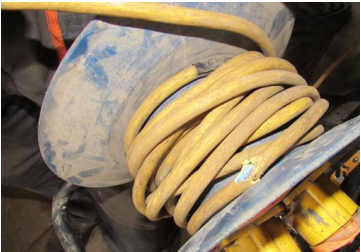
| <b>4 – Cable Damaged</b><br>As per image 3, reels can hide damage and cable needs cleaning / inspecting | <b>5 – Cable Damaged</b><br>Obvious wear to extension cable | <b>6 – Cable Profile</b><br>Thickness of insulation is critical for cable performance – wear to sheath will affect its performance |
