Technical Bulletin No: 10-2014

Title: Husqvarna K750 & K760 Cut-Off Saw Inspection
Authors: TfH Ltd

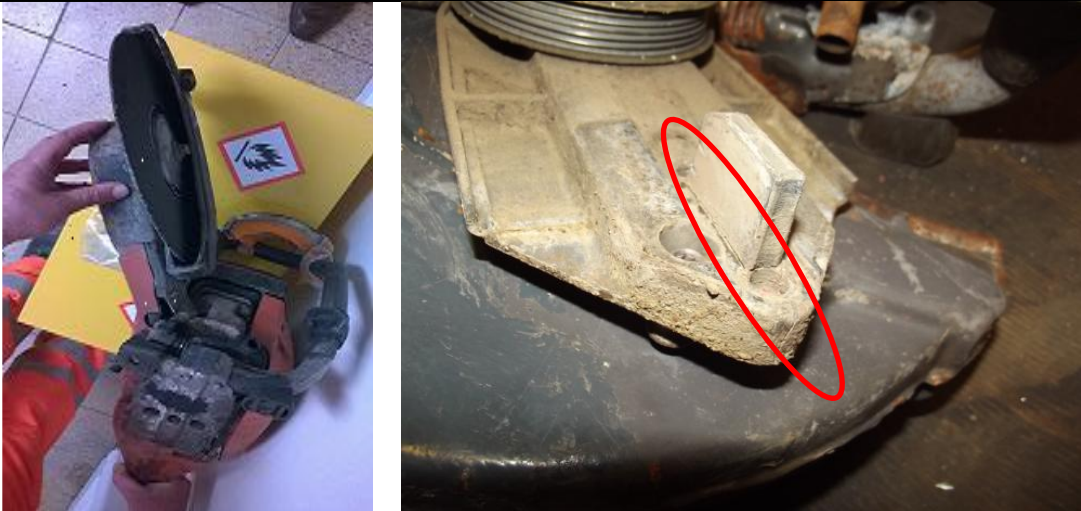
Title:	Husqvarna K760 Petrol Cut-Off Saw Inspection	
Priority	Red	Red – Audit Rating: Non-Conformance-Major
Legislation:	PUWER - HASWA S.6	
Brief Description:	An issue has been identified regarding fractures and potential for displacement of the drive head (bearing housing) on Husqvarna K750 and K760 petrol cut-off saws.	
Kit Affected:	Husqvarna K750 and K760 petrol cut-off saw	
Images:		
Failed item and early stage cracking evident along casting (circled) on another machine

Recommended Actions:	100% inspection of K750 and K760 Cut-Off saws to check for cracking to the drive head casting. If cracks are identified, please complete the feedback form (page 2). If no cracks are found, record on your service record and consider marking the machine to enable easy confirmation that the check has been completed. If repairs are carried out, retain the cracked component and record the serial number of the affected machine for feedback to HAE.	
Notes:	Please use the fax-back form overleaf to advise regarding any cracked items discovered. The bearing housing has been revised on serial number xxxxxxxx onwards. Please also check that the rotating guard can be adjusted / rotates.	
Circulation:	workshops, mobile service and management team

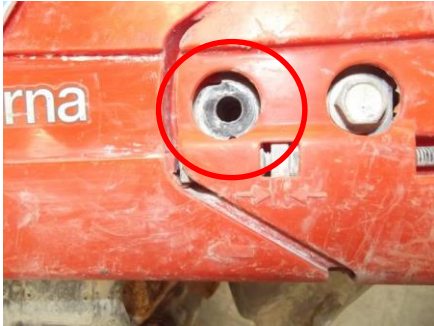
Cracking affects the drive head casting - known as bearing housing by the manufacturer. To fully inspect, remove the drive head. Cracking may also be visible by removing the inner retaining bolt and inspecting the threads of the casting for cracking using a suitable torch.
