# Technical Bulletin No: 2-2014

<b>Title:</b>	<b>Reciprocating Saw Inspection</b>		
<b>Priority</b>

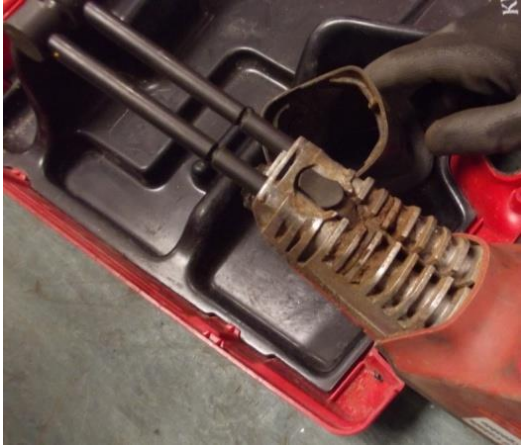
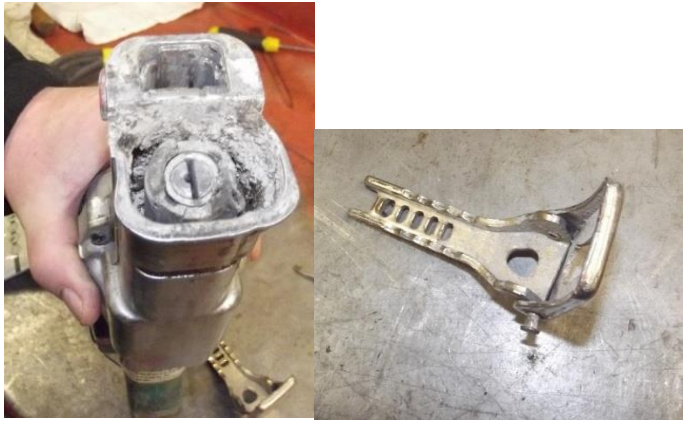
Amber – Audit Rating: Non-Conformance-Minor	
<b>Legislation:</b>	PUWER, HASWA S.6		
<b>Brief Description:</b>	During SafeHire audits a number of issues have been found on reciprocating saws. Saws affected include a range of models and manufacturers. Majority of issues are “concealed” under the boot / gearbox / drive casing cover and more thorough examination would prevent this.		
<b>Kit Affected:</b>	Reciprocating Saws – all models and manufacturers		
<b>Images:</b>			
Recip foot / pipe clamp not locking due to build-up of debris under cover / in orifices		Heavily contaminated tool holder Bent, damaged and broken feet

<b>Recommended Actions:</b>	100% check as part of combined inspection and test: Peel back / removal of boot to allow inspection of casing, retaining bolts / screws and foot security / adjusting mechanism. Consider threadlock for fasteners where appropriate.

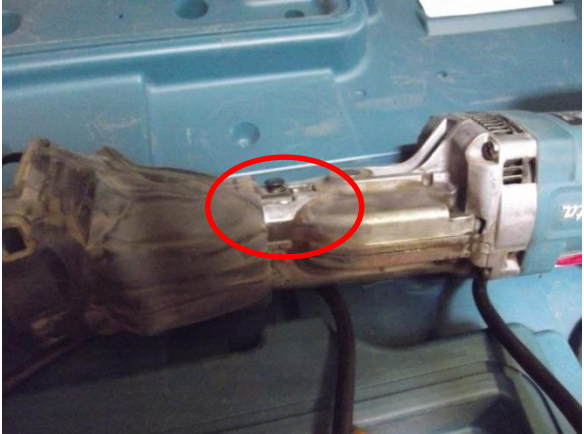
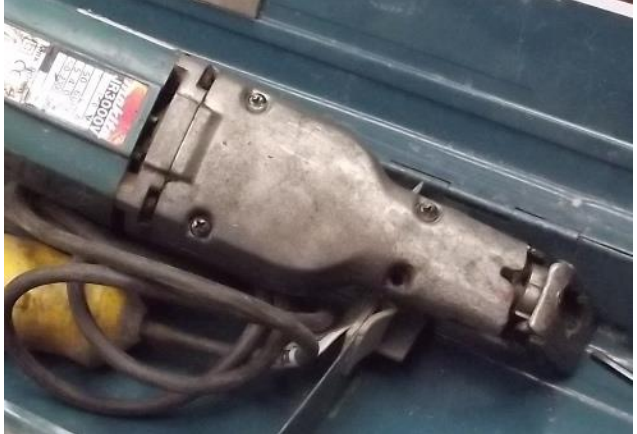
Adjustable foot mechanism retaining bolt loose (circled)		Screws – have been loose, missing and / or incorrect for application
