Title:	Submersible and Puddle Pump Servicing
Priority	Amber – Audit Rating: Non-Conformance-Minor
Legislation:	PUWER, HASWA S.6, CoSHH
Brief Description:	During SafeHire audits a range of issues have been identified regarding contamination / lack of cleaning / damage to impellers of sub, puddle and other impellor type pumps. Removal of base of pump unit (typically two to three fasteners) / visual examination of pump body is not being consistently completed during service.
Kit Affected:	Sub-Pumps, Puddle Pumps and other impellor type pumps

Title: Sub and Puddle Pump Servicing
Authors: TfH Ltd

Bulletin Number: 7-2014
Reviewed by: Tech. H&S Panel

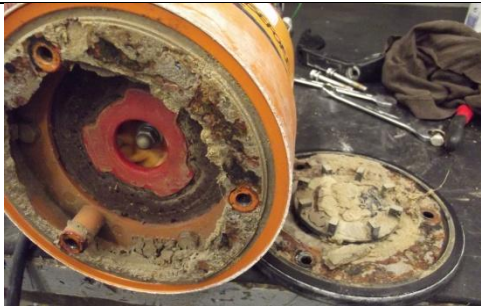
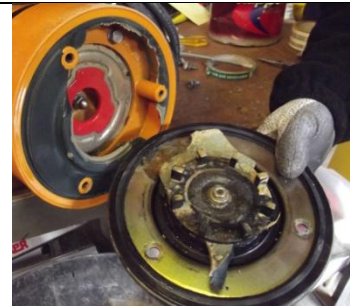
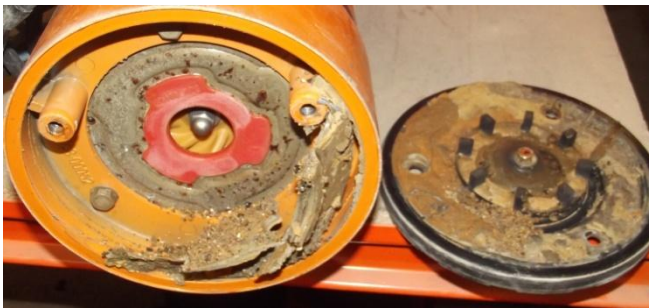
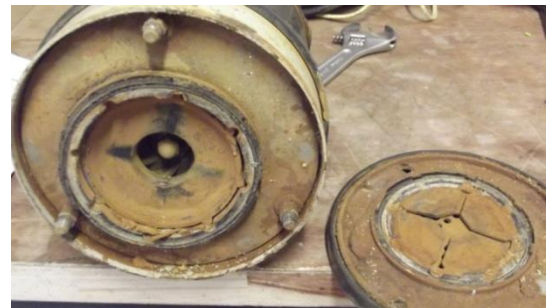
Sub pump contamination – sewage waste, what appears to be some form of resin and ‘normal’ debris

Note: 50mm pumps and similar products can be inspected for contamination using an inspection torch or similar through inlet, outlet and drain without need for removal of casings.

Recommended Actions:	Review service procedure / risk assessment to ensure pumps are flushed, cleaned, tested (flow and electrical) ensuring contamination is removed. Include consideration of potential for exposure of workers to harmful substances from previous use i.e. sewage and use of disinfectant or similar may be included in your Safe System of Work
Notes:	Consideration of applying a suitable lubricant or preservative to protect components during storage / inbetween hires may also be worthwhile
Circulation:	workshops, mobile service and management team

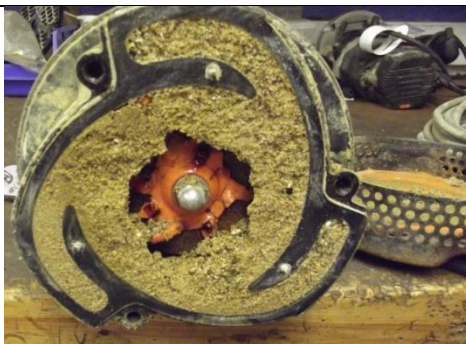
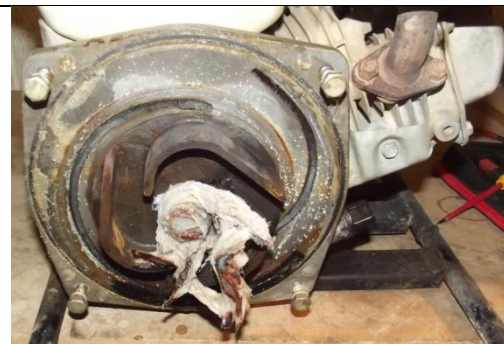
Sub-Pump – debris and a destroyed impellor 50mm pump, sewage waste contaminating pump
